LITTLE SCHUYLKILL DAM  
SCHUYLKILL COUNTY, PENNSYLVANIA  
NATIONAL I.D. NO. PA-00655

⑥ National Dam Inspection Program. Little Schuylkill Dam (National I.D. Number PA-00655), Schuylkill River Basin, Schuylkill County, Pennsylvania. Phase I Inspection Report.

Name of Dam: Little Schuylkill Dam  
County Located: Schuylkill County  
State Located: Pennsylvania  
Stream: Little Schuylkill Creek  
Coordinates: Latitude 40° 50.2' Longitude 76° 0.3'  
Date of Inspection: 23 May 1978

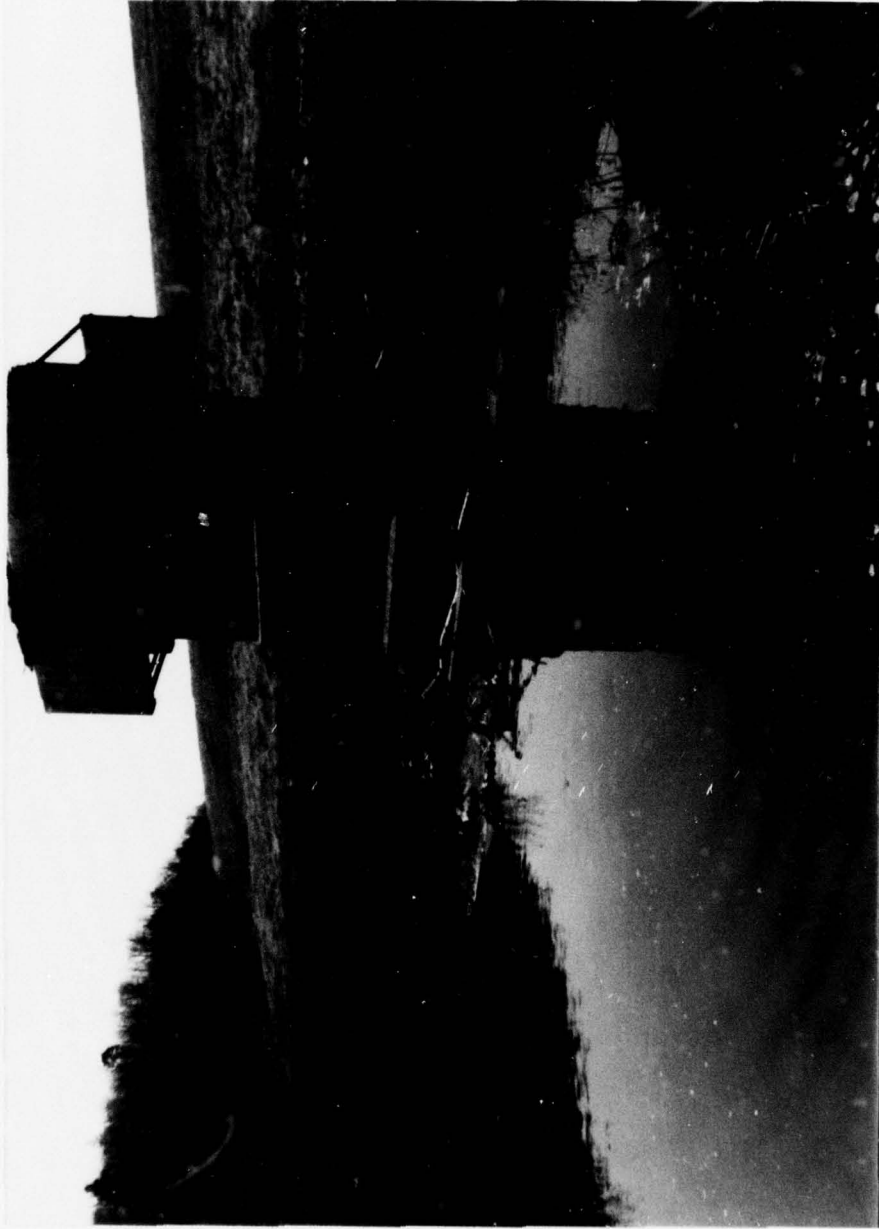
PHOTO NO. 2

c. Appurtenant Structures. At the time of this inspection, the water level was at the base of the control riser. Some debris has accumulated around the riser allowing the water to back-up approximately one foot. It is understood from the Owner's representative that a local contractor cleans this riser at least once per year. Debris was noted on the top of the riser, indicating that flood waters had inundated the riser to an elevation of at least 1050 prior to the last clean-up. All appurtenant structures were inspected and observed to be in good condition.

PRINCIPAL SPILLWAY ENTRANCE WITH TWO INTAKE LEVELS.  
NOTE TRASH ACCUMULATION AT ENTRANCE OF LOWER INTAKE.  
TRASH ALSO LIES ON UPPER INTAKE.

1. The log currently wedged at the base of the entrance tower should be removed.
2. It is recommended that the Owner monitor the downstream seep, especially after periods of retention behind the embankment.

b. Operation and Maintenance Procedures. Because of the location of the dam upstream from the populated area of Tamaqua, a formal procedure of observation and warning during periods of high precipitation should be developed and implemented. The Owner should develop a maintenance checklist to insure that all critical items are inspected on a periodic basis. It is recommended that the trash racks be kept thoroughly cleaned to prevent clogging of the system.
